An Evaluation of IDOT's Current Underdrain Systems

**Physical Research Report No. 120
December 1995**

Illinois Department of Transportation
Bureau of Materials and Physical Research

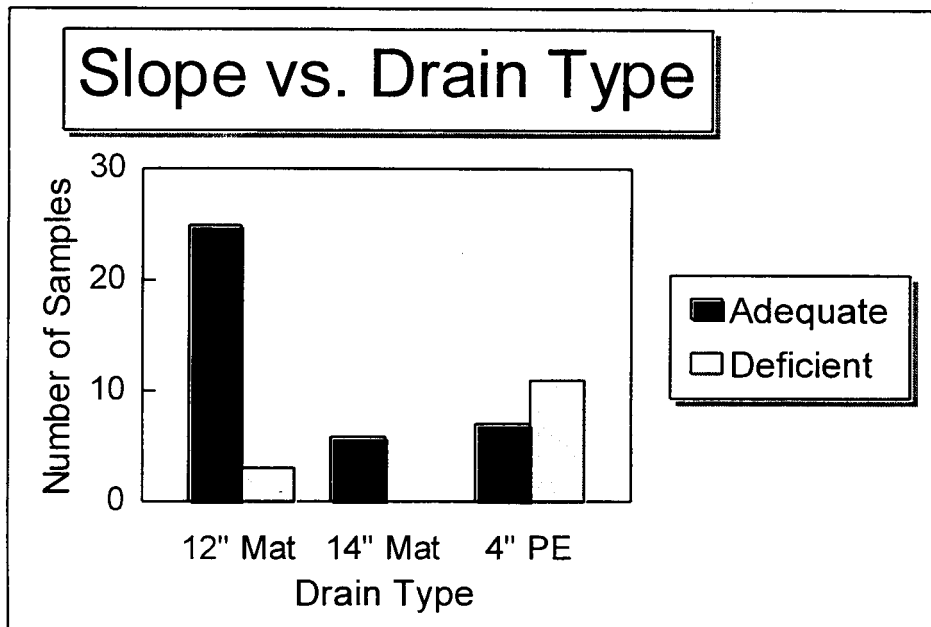
Figure 6. Qualitative assessment of underdrain longitudinal slope.

order to provide a proper outlet slope without burying the headwalls in the ditchline. Sags were found to be common, with 11 of 18 pipe underdrain excavations showing some water ponding. Although this is not an ideal condition, the majority of the water should still drain away, while the remainder should pose little threat due to its distance below the pavement structure. A qualitative assessment of the adequacy of longitudinal slope of the various underdrain types is illustrated in Figure 6.

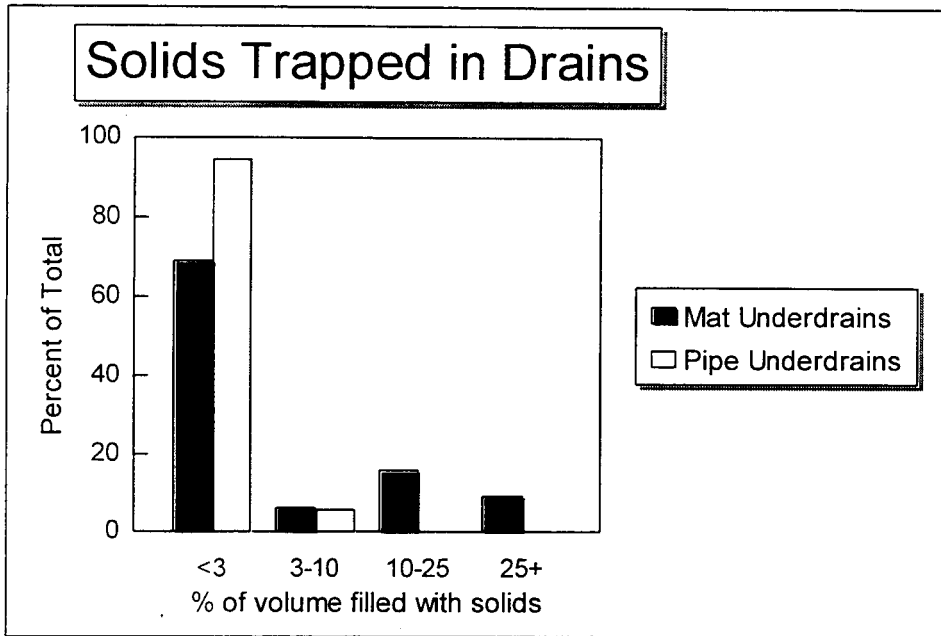
Figure 12. Distribution of percent solids vs. drain type.

the mat underdrains (see Figure 12). This appears to be a result of the beneficial

filtering properties of the granular backfill used for pipe underdrains and not for mat underdrains, which were all backfilled with in situ material. Table 3 summarizes the type and amount of solids found in the underdrain field samples.

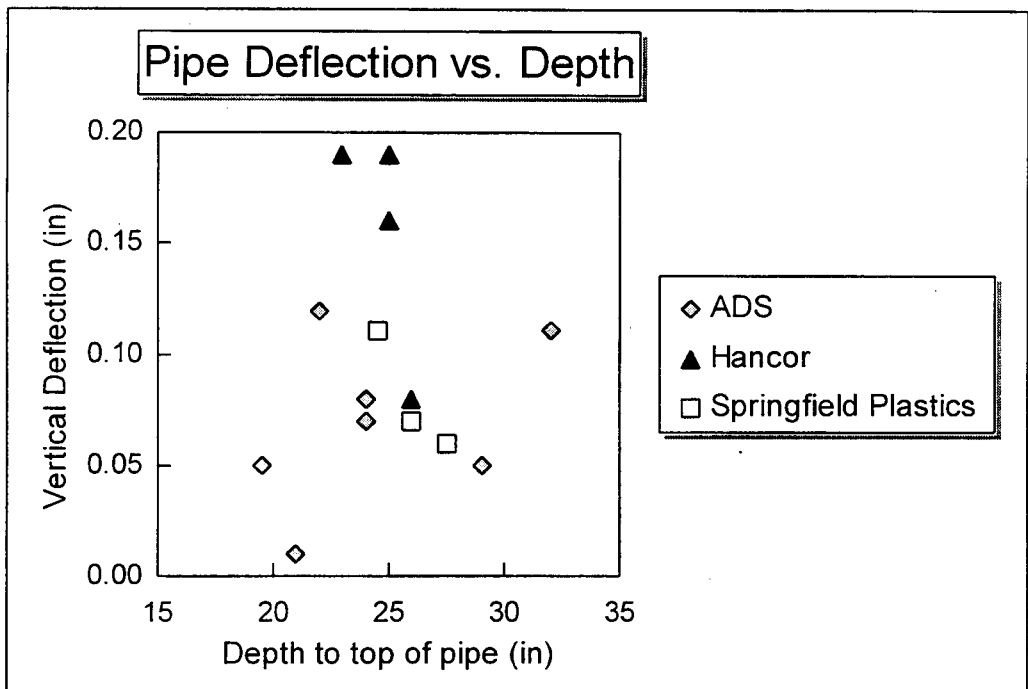
Figure 13. Plot of pipe deflection vs. depth.

Most of the pipe depths were measured in the field. Using these depth values along with the estimated vertical deflections, a comparison can be made between the two variables. The purpose of the comparison is to determine if decreasing the underdrain trench depth will have an adverse effect on pipe deflection. If not, a feasible solution to the problem of outlets located too close to the ditchline would be to raise the underdrain elevation. A plot of pipe deflection vs. depth (Figure 13) reveals there is no correlation between trench depth and deflection. It appears that deflection is determined by some other factor such as installation procedure. Therefore, decreasing the trench depth from 30 inches to 24 inches should be a viable option.

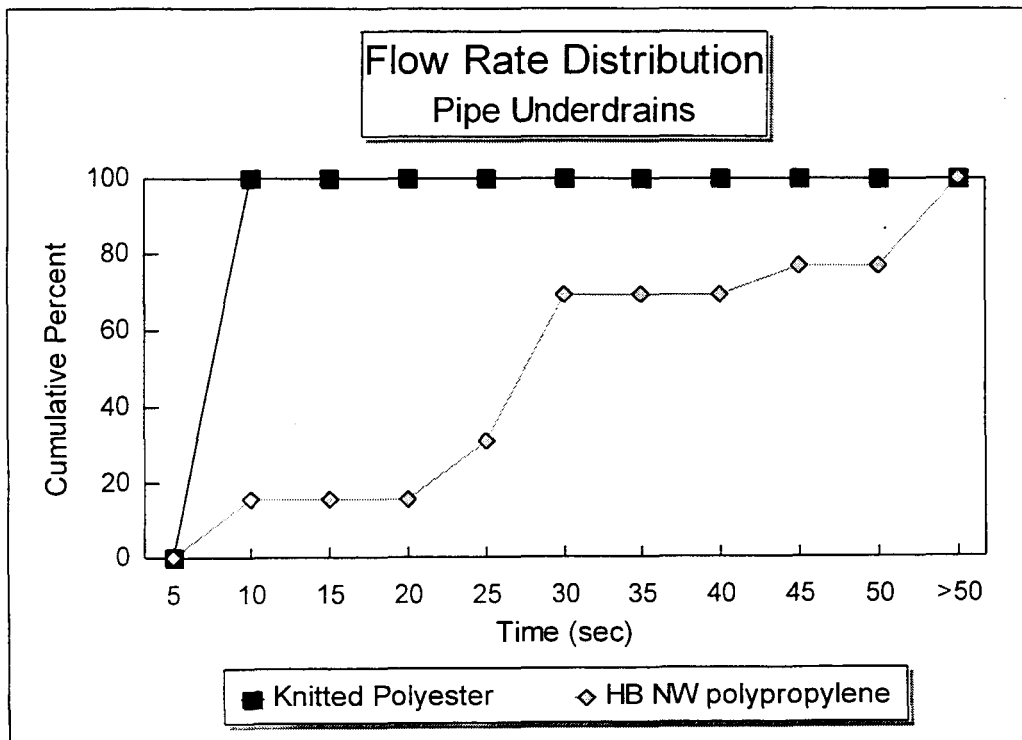
Figure 22. Flow rate distribution for pipe underdrain samples.

diameter acetate tube suspended over a 1000 ml beaker. The geotextile was oriented so that the water would flow in the same direction as in the field. The entire test was videotaped and the time for the water to pass through the fabric was recorded. In addition, the color of the filtered water was noted. The geotextile samples were taken from the bottom half of the underdrains. Although this probably represents the worst case, it was felt that, with time, the rest of the geotextile would approach the same condition. Table 6 summarizes the results of the permeability testing. From the data in Table 6, plots were prepared comparing the flow rate distribution for the various geotextiles. Since the pipe underdrains contained granular backfill and the mat underdrains did not, they were considered separately. Figure 22 contains a plot of the results of the permeability tests pertaining to the pipe underdrain samples.

When new, most geotextiles tested let water through as fast as it could be poured (<10 seconds). However, it took approximately three times as long for the water to pass through the heat-bonded, non-woven, polypropylene when new and this material showed a greater tendency to retain fines and lose permeability. It can be seen in Figure 22 that the knitted polyester did not lose any permeability with time, whereas less than 70 percent of the heat-bonded, non-woven, polypropylene maintained its original, slower, flow rate. All of the knitted polyester samples let the water pass through in under 10 seconds whereas less than 20 percent of the heat-bonded, non-woven, polypropylene samples could make the same claim.

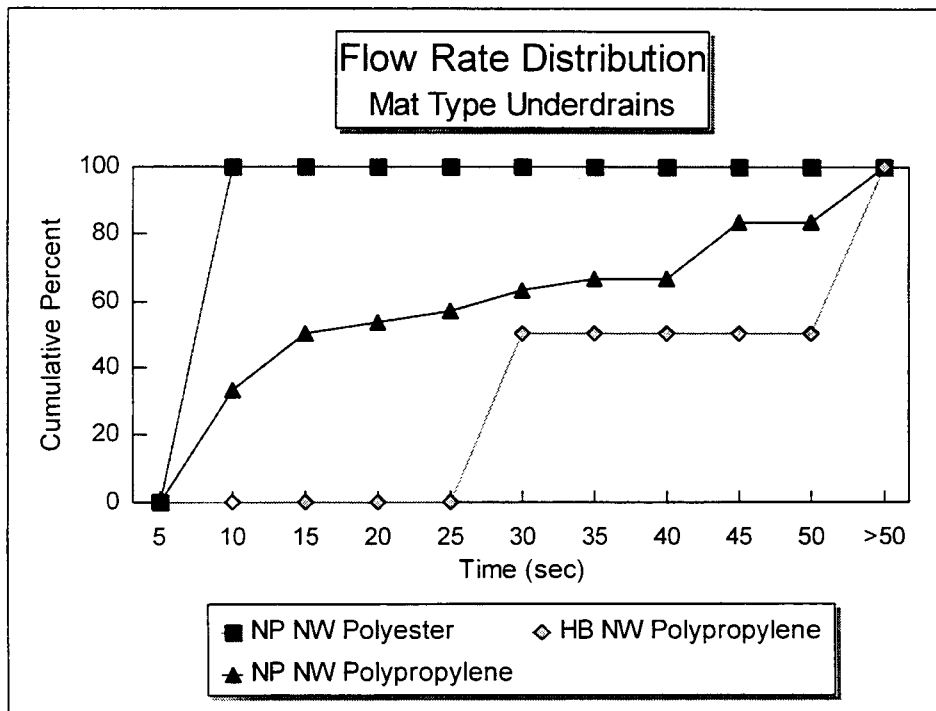
Figure 23. Flow rate distribution for mat underdrain samples.

Figure 23 contains a plot of the permeability test results pertaining to the drainage mat samples. The needle-punched, non-woven, polyester performed the

best of the mat underdrain geotextiles. It should be noted that both samples of this material were taken from areas with a granular subgrade. Therefore, the difference may be more attributable to the cleaner subgrade than to a material superiority. The heat-bonded, non-woven, polypropylene again performed the worst of the fabrics tested. Without the aid of a granular backfill, the performance was even worse than it was for the pipe underdrains. Intermediate results were obtained from the needle-punched, non-woven, polypropylene. A wide range of values were obtained with this material ranging from under 10 seconds to over one hour. The samples with the slowest flow rates were found to contain a coating of silty clay on their interior.
